Supplement to Troubleshooting Guide SP30Si, SE30/125S, SE25/110S

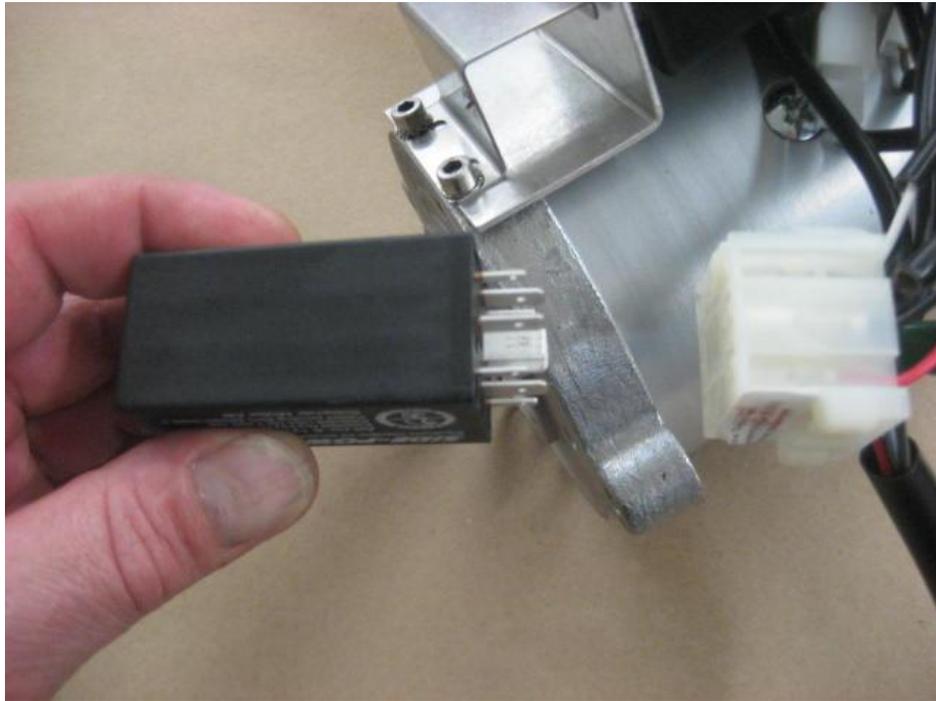
Step 1: Since the White IPC wire cannot easily be disconnected unplug the control box instead. The control box fits very tightly in the plug so it helps to wiggle it back and forth to remove it.

Note: Do not use a metal object to remove the control box unless power has been disconnected.

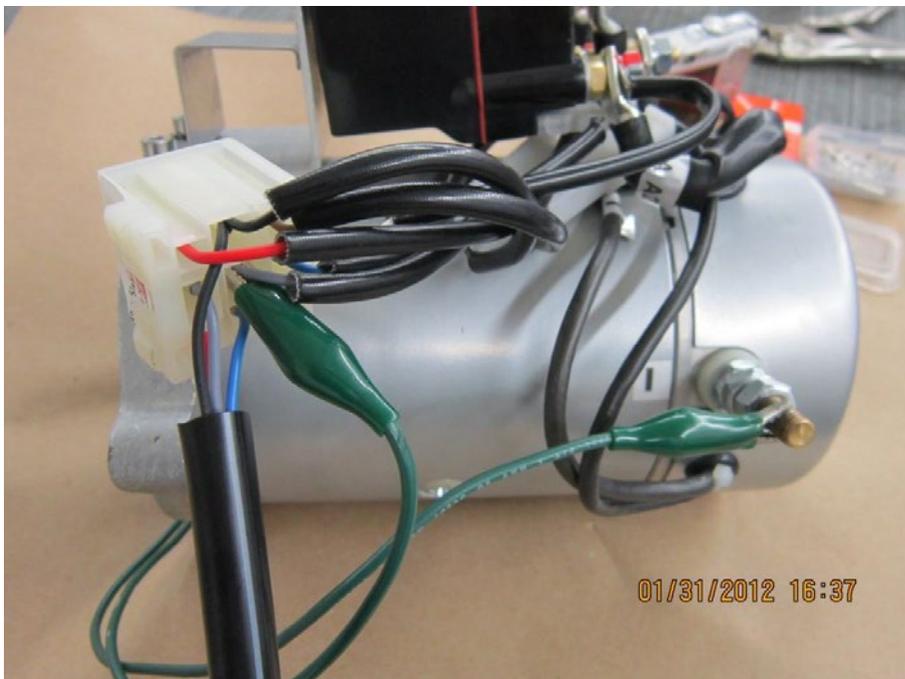
Step 4: Jump to the A1 Negative Battery Stud as in the trouble-shooting guide. If the motor does not run, verify input voltage on the Solenoid Positive Feed Terminal and check output voltage on the A2 Terminal.
